SUBJECT: UPDATE TO MOTION OF 5/7/19 BY COUNCILOR CIRILLO

REQUEST THE CITY MANAGER DIRECT THE PROPER DEPARTMENT TO LOOK INTO OPTIONS ON HOW TO IMPROVE THE LIGHTING FOR THE ENTIRE LENGTH OF THE RIVERWALK FROM

BOOTT MILLS TO LELACHEUR PARK

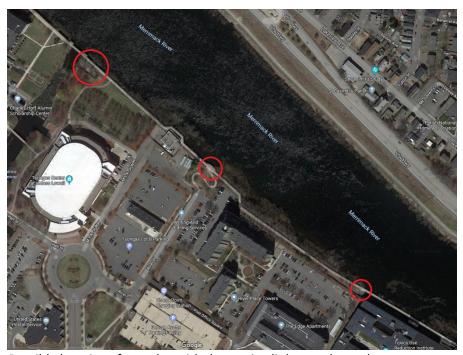
Possible locations for nodes with decorative light or other enhancements

Several walk-through participants articulated a desire for decorative light such as string lights or colored lights. Although it might be infeasible to have an installation along the entire length of the Riverwalk, key nodes such as the amphitheater or sunken area behind Tsongas Center may be feasible. The City will evaluate the durability, historic impact, and cost of this type of installation. Lighting along the railing, which would be a longer-term installation, will also be evaluated.

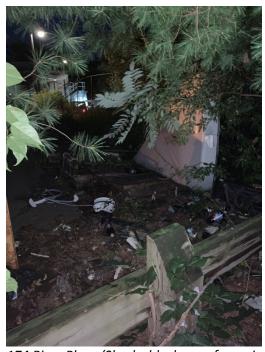
174 River Place (Shrubs block area from view)

- Behind Boott Mills: Needs pruning of vegetation overhead, encroaching, and impacting walls
- Behind River Place Tower: Needs a check for invasive species and possible pruning
- 174 River Place: Needs removal of low vegetation and cleanup (on boundary between land owned by City and University of Massachusetts Lowell)
- Behind Lawrence Mills: Needs pruning of vegetation overhead/blocking light

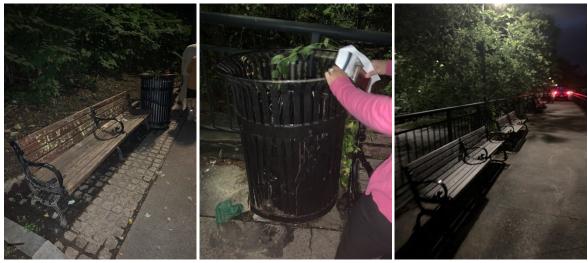
Benches and trash cans along Riverwalk

The group identified benches along the Riverwalk that required repainting and repairing, including the installation of missing slats. These slats may be expensive, so an overall feasibility study may be undertaken for long-term maintenance. The City will also investigate alternative materials for slats such as plastic wood that would retain the overall character but have longer durability. This also should include making sure barrels are bolted down and in good condition.

In the meantime, a repair project was undertaken by the Parks Division of DPW in September to replace missing slats, and all benches were confirmed to no longer have missing slats.
